DETERMINING THE DAMAGE INFLICTED BY TOURISTS ON THE CURONIAN SPIT NATIONAL PARK AND PREVENTIVE MEASURES IN DUNE CREATION

Morkūnaitė R., Karmaza B., Bauža D.: Determining the damage inflicted by tourists on the Curonian Spit National Park and preventive measures for dune creation. *Ekológia (Bratislava)*, Vol. 31, No. 3, p. 341–353, 2012.

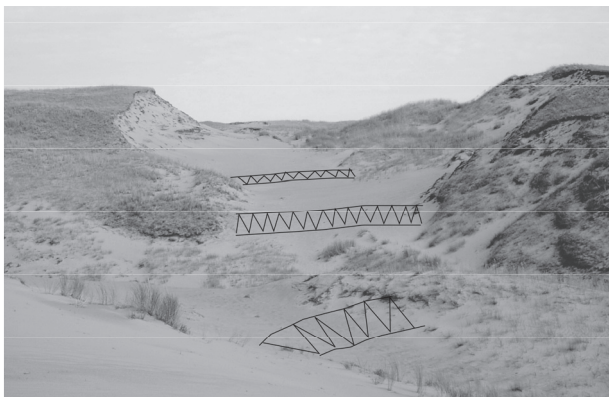
Fig. 5. Places for possible barriers in New Nagliai dune massive. (photos by A. Česnulevičius)

The educational footpath of Nagliai dune is in the CSNP near the Pervalka settlement. This path was built for visitors to cross the dunes and to observe the Curonian lagoon. The path begins at the 7th parking area and extends 700 m eastwards across the Nagliai dune and towards the Curonian lagoon (Fig. 5).

The processes of wind erosion occurring in the western slope of the dune massif must be stopped by regulating the number of visitors, and by building artificial barriers which obstruct the movement of sand. In the Naujieji Nagliai dune massif, the barriers should wall in the new deflation basins (Fig. 5).

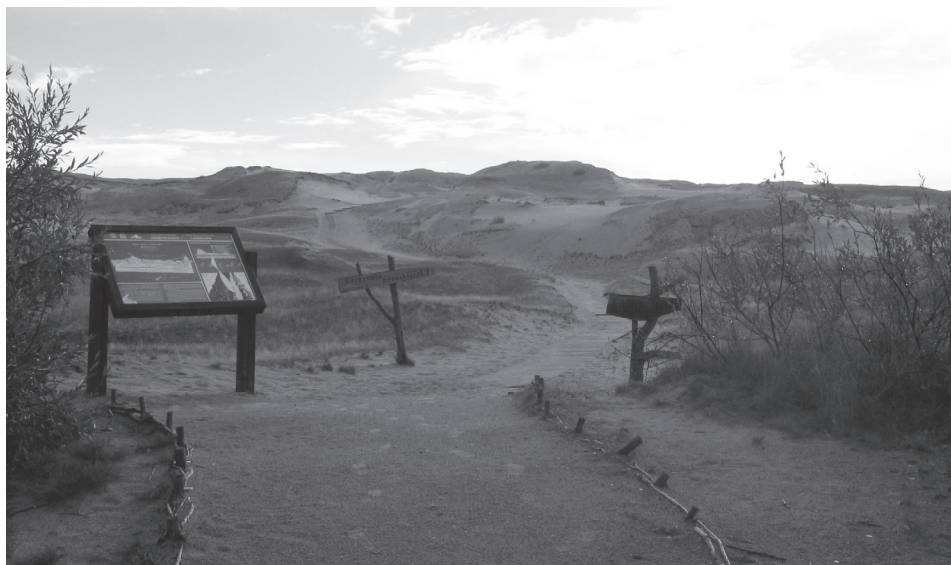
Fig. 6. Common view of path from the beginning towards Nagliai dune. (photo D. Bauža)

surface facilitates wind acceleration when wind and path directions coincide (Fig. 6). Visitors walking along the sides of the wooden footpath inflict damage to this sector. In some places, trampled areas are 10 times wider than the 1.2m wooden footpath, and human footprints are apparent.

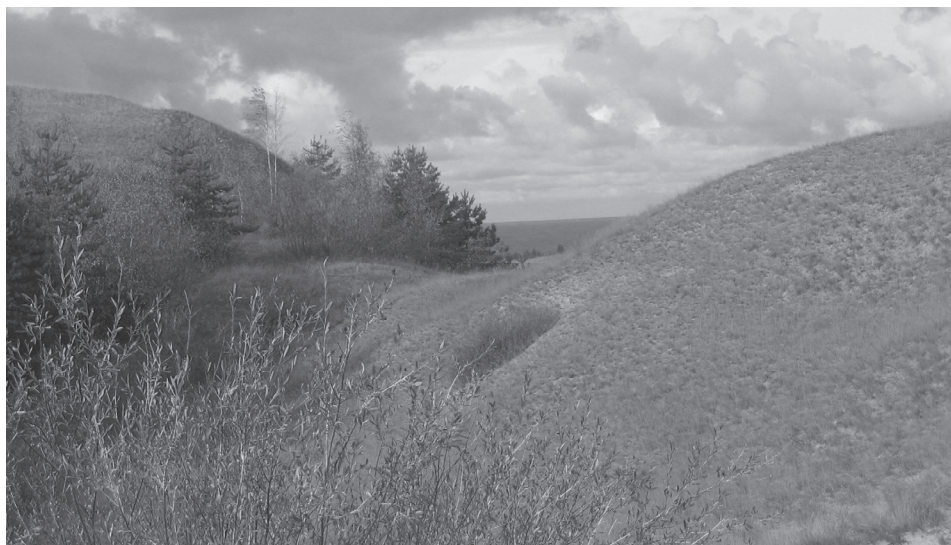
Fig. 7. The place and the type of planting recommended. (“big” kanjon near Lydumas cape). (photo by D. Bauža)

The other investigated areas obviously lack vegetation cover, and the open area near the Lydumas cape forms a “runway” for wind. Appropriate vegetation must be planted to obstruct wind action (Fig. 7). As it is, the dominant western and north-western winds have formed a corridor for sand transport into the Curonian lagoon. A few spruce trees and birches obstruct NW winds and vegetation is flourishing behind them (the left side in Fig. 7). Meanwhile, turf has no time to develop in the open areas. This area should be planted to shade the winds, and Mountain pine is perhaps the best species for this purpose.
