LAND USE CHANGES OF RIVER DYJE FLOODPLAIN IN REACHES NOVÝ PŘEROV – BROD NAD DYJÍ AND NOVÉ MLÝNY – LEDNICE, CZECH REPUBLIC, IN THE PERIOD OF 1830–2001 AS A REACTION TO THE RIVER DYJE CHANNEL REGULATIONS

HANA SKOKANOVÁ

Skokanová H.: Land use changes of river Dyje floodplain in reaches Nový Přerov – Brod nad Dyjí and Nové Mlýny – Lednice, Czech Republic, in the period of 1830–2001 as a reaction to the river Dyje channel regulations. *Ekológia (Bratislava)*, Vol. 27, No. 1, p. 82–98, 2008.

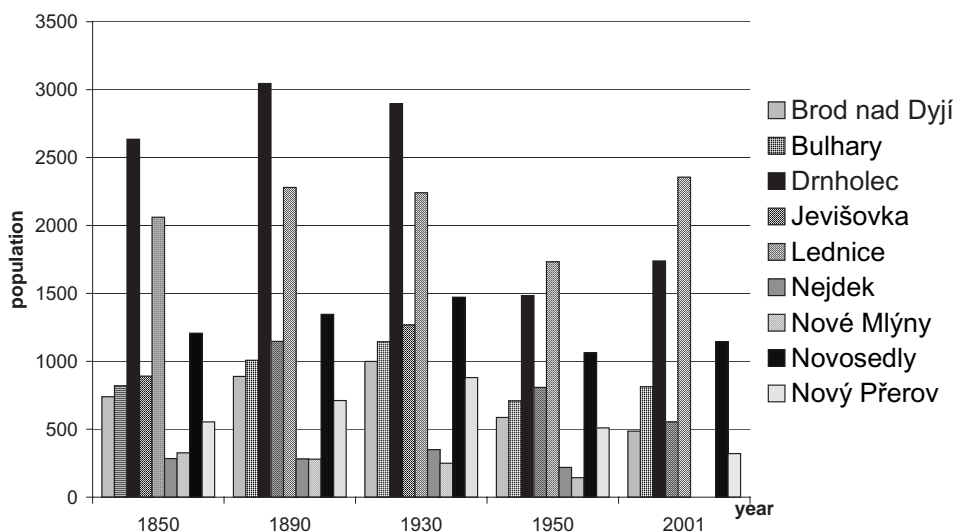
Fig. 2. Demographic progress in municipalities in the study area in 1850–2001.

The main socio-economic factors include demographic progress, economic development and political situation. Demographic progress in the study area is shown in Fig. 2.

The population was at its height in 1930 in the majority of municipalities. The only exceptions were Lednice and Drnholec whose peak occurred in 1890 and Nové Mlýny which peaked in 1850. Nejdek was integrated with Lednice in 1960, so the information about population for 2001 is for both villages. The situation is similar in Nové Mlýny which was integrated with Příkladky.

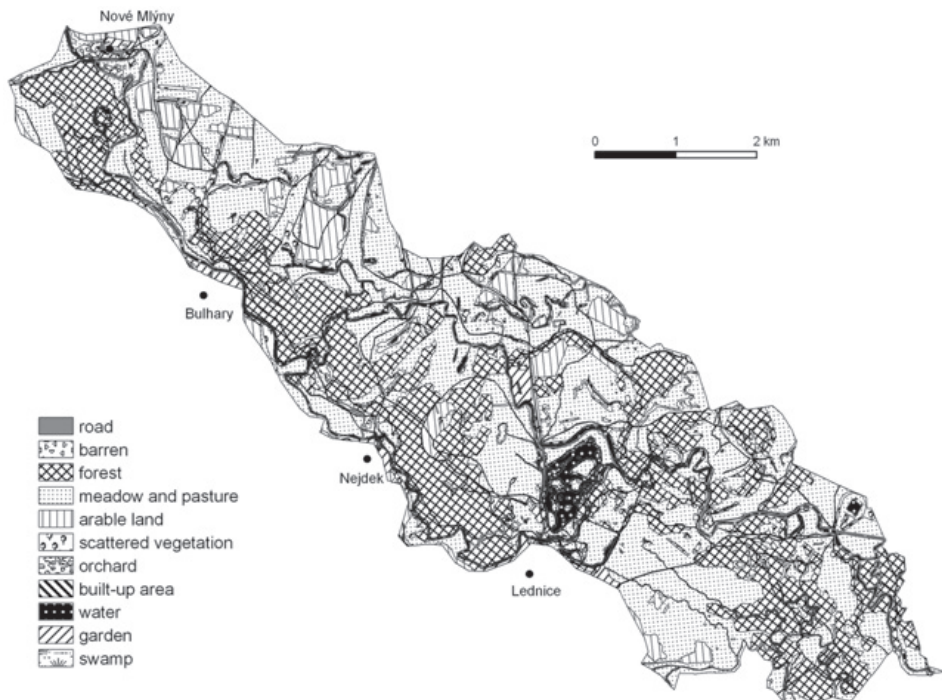
Fig. 7. Land use in the reach 3 in 1830.

Similarly to reach 1, the reach 3 had the biggest proportion of meadows and pastures and gardens in 1830 (Fig. 7). At the same time, the biggest proportion was recorded for water areas in the form of many oxbows – remnants of anastomosis. These oxbows were situated mainly in the area of Obelisk (north of Lednice) and Herdy (northwest of Lednice). Regarding swamp area this period, as well as 1890, showed the smallest proportion. Swamps were linked with oxbows both northeast of Obelisk (locality of Trokvis oxbow) and in the area of Herdy (around Azont lake) but they were also situated in the north-western part of the reach. The smallest proportion of arable land and of forests and shrubs from all periods is recorded. The proportion of forest and shrubs, however, was the second biggest (34.5%) after meadows and pastures within this period. Blocks of arable land concentrated mainly on the left bank, in the section between Nové Mlýny and Obelisk.

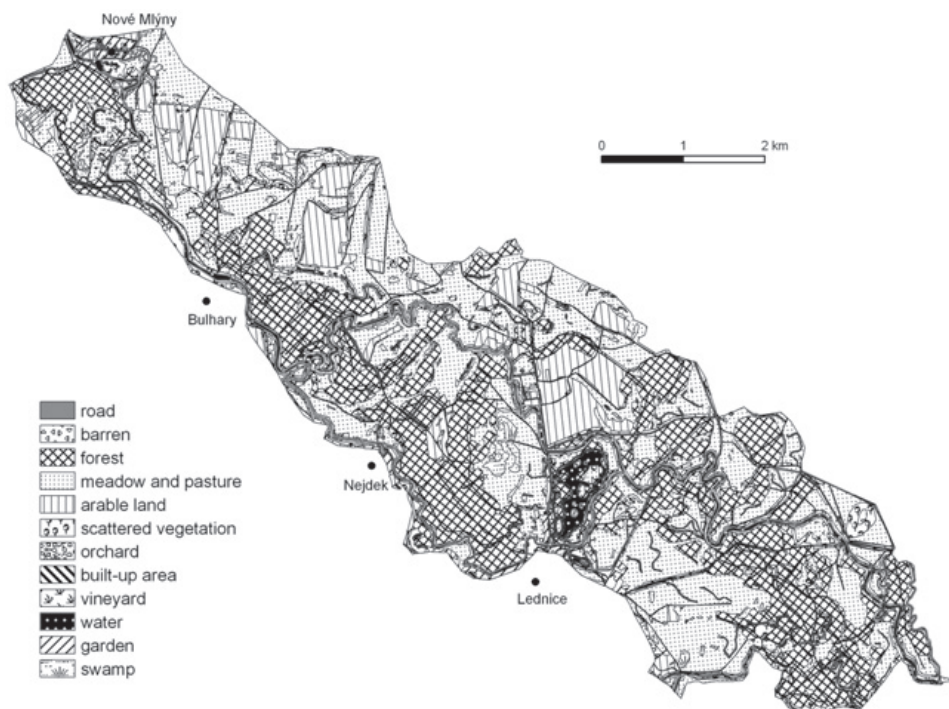
Fig. 9. Land use in the reach 3 in 1955.

Also the year 1955 (Fig. 9) registered a decrease in meadows and pastures (for 2% comparing to 1890) and gardens (for 0.1%); and an increase in forest and shrubs (0.5%) and

arable land (3.3%). The area covered by arable land expanded on the left bank of the Dyje in the locality Louky od Příkladuk and north of Zámecký rybník pond (above Lednice). Several oxbows were restored in Herdy and Přední louky areas and east of Lednice. Their restoration meant a decrease in barrens (for almost 3%). At the same time, a significant increase in swamps was recorded, which was the result of waterlogging meadows at a locality called Pastvisko (northwest of Lednice). Meadows situated at the mound of Včelínek creek (south-east of Lednice) and south of Křivé jezero lake were considerably waterlogged, too.

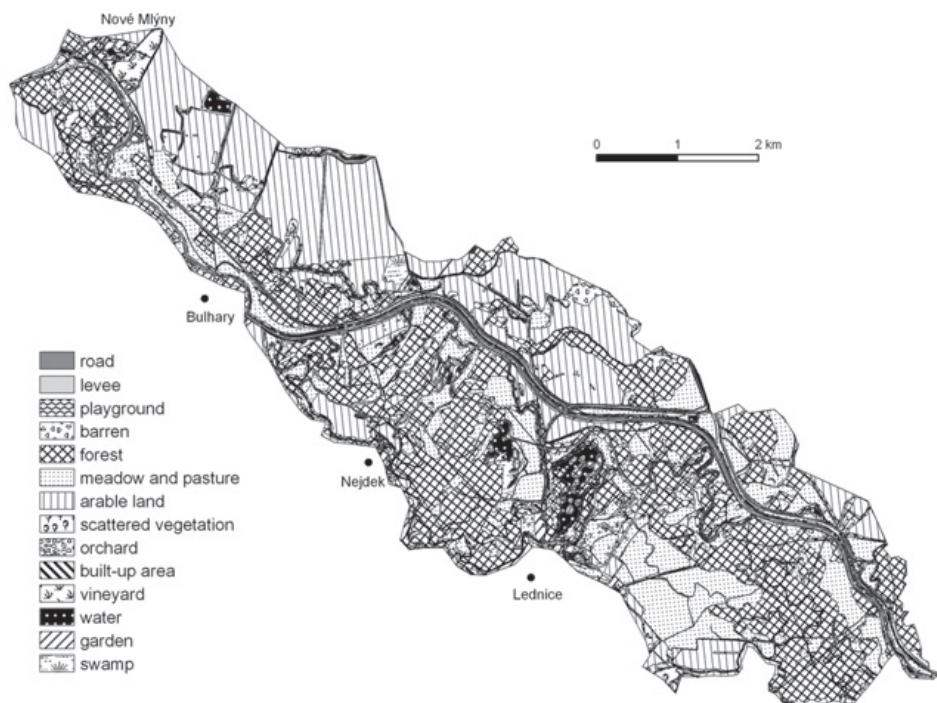
Fig. 10. Land use in the reach 3 in 2001.

The most important changes affecting this reach happened in the second half of the 20th century and are shown in Fig. 10, representing 2001. This period registers noteworthy increase in the arable land (14.2% comparing to 1955 and 17.7% comparing to 1830). This increase has been enabled by the construction of Nové Mlýny reservoirs which precluded regular spring floods and thus made it possible to plough meadows and pastures on the left bank of the Dyje from Nové Mlýny to Obelisk. Together with them, meadows on the right bank have been ploughed in the areas west of Křivé jezero lake, northwest of Nejdek and north of Včelínek creek. The only larger areas of meadows remain east of Lednice, in the eastern part of the reach (localities Přední louky and Spálenisko) and north and south of Bulhary. The

areas of forests and shrubs have extended at the detriment of meadows and pastures in the Herdy area and east of Zámecký rybník pond. A continuous belt of forests has been disrupted by a construction of an artificial channel in the reach between Bulhary and Janův hrad. 1990s experienced a small increase in water areas thanks to the revitalizations of several forest canals and oxbows. Another increase in an area is recorded for swamps; the largest areas are in two localities: Herdy (Azont lake, Dlouhé jezero lake) and north and east of Panvastr (north of Herdy on the left bank of the Dyje). Also permanent cultures (east of Nové Mlýny) and built-up areas have extended a little. Arable land has started to decrease after 1990 and has been turned into barrens or transferred back into meadows. This process has resulted in similar proportions of both arable land and meadows and pastures (about 24%).
